Site Assessment Essentials

EPA Region III

CASE STUDY ABOUT PFAS BLADES GROUNDWATER

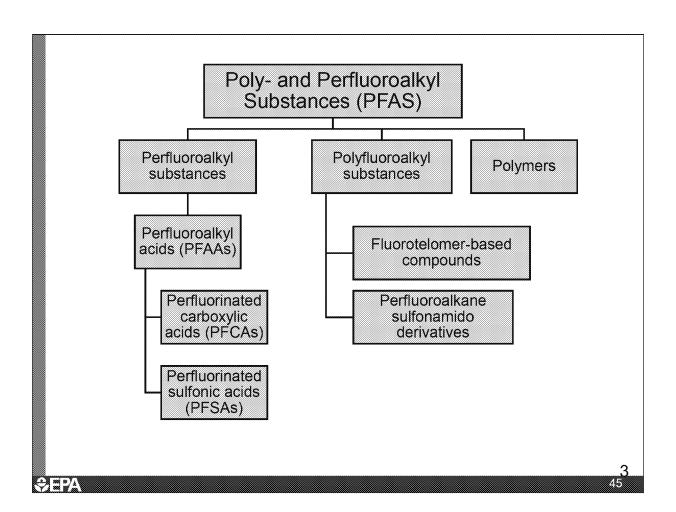
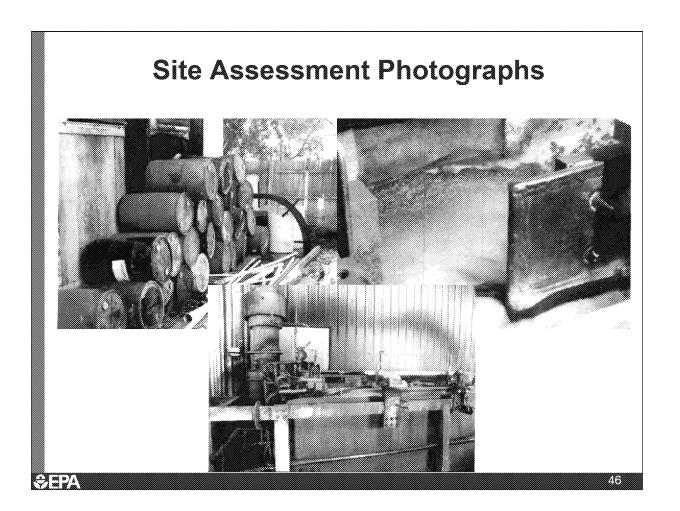
The data and facts that were easily ascertained during the SI using environmental samples and standard hydrological methods: Further, PFAS distribution; field scale lithology; subsurface hydrogeologic conditions - including groundwater flow direction, velocity, and influence of heterogeneous geology. Onsite, EPA identified from the previous boring logs three alternating sand/clay layers – thus becoming the zones to target from groundwater wells.

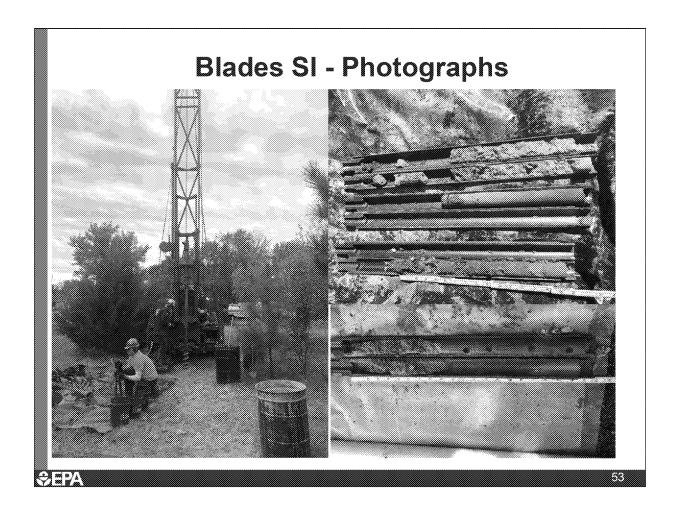
EPA has identified three alternating lithological layers of sand and dense clay zones of varying thickness.

Drinking water aquifers 66-96 feet in this case was evaluated based on transmissivity and saturated aquifer thickness in order to determine new OB well density and screen depths.

Keep in mind the travel time may be on the order of years to decades with minimal degradation. Dilution factor i.e. distance from the sources would be the only issue to keep in mind.
